# Damage from the Tohoku-Pacific Ocean Earthquake and future prospects

March 30, 2011

Nippon Telegraph and Telephone East Corporation

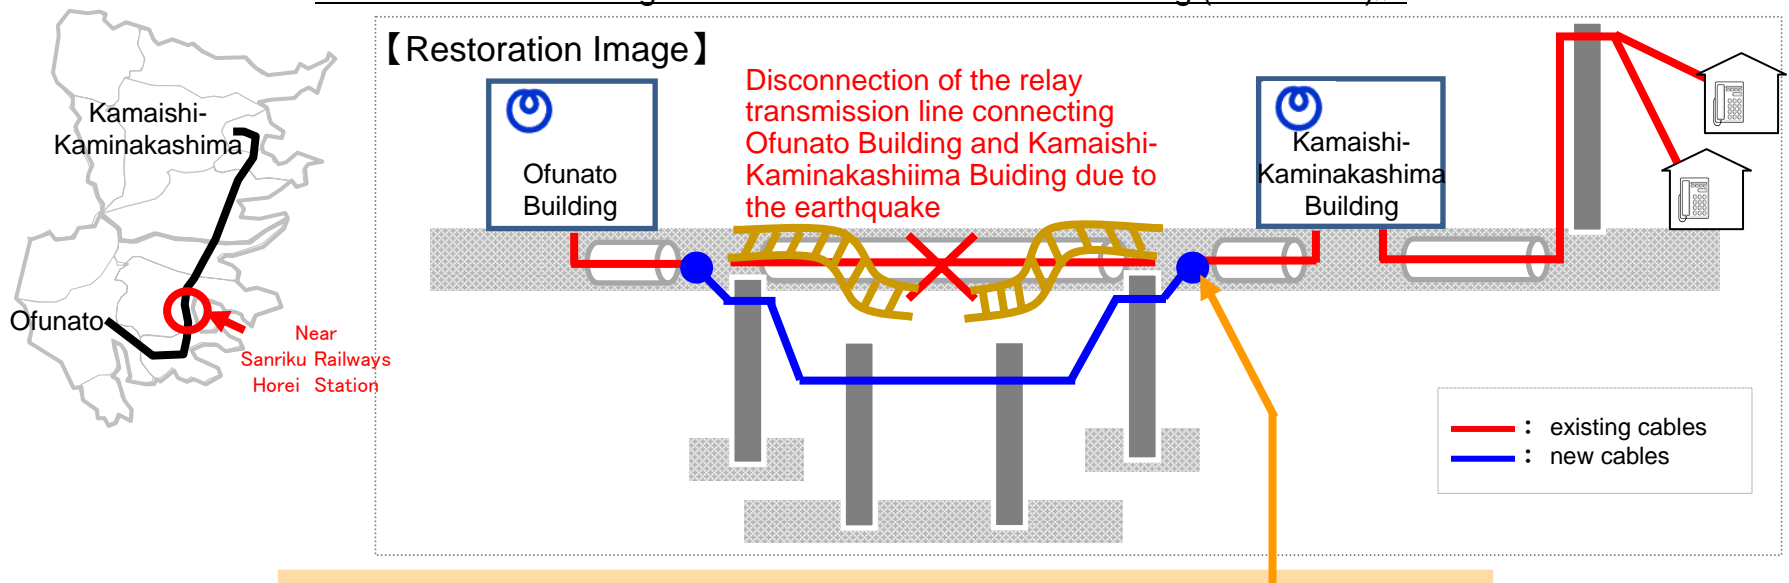
《from Ofunato Building to Kamaishi-Kaminakashima Building (Iwate Pref.)》

Example of restoring transmission through the establishment of a backup relay route

- Establish backup relay routes or switch routes to achieve connectivity at disrupted points or to bypass damaged relay transmission lines.
- Main relay transmission lines to be secured through the aforementioned measures.

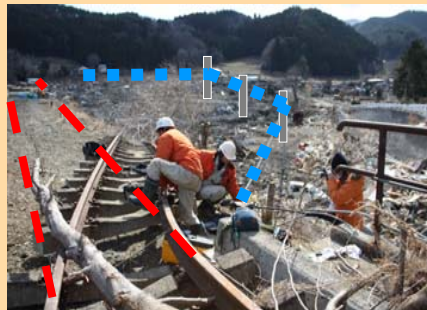
Cables were disconnected along with the Sanriku Railways' railroad track. 11 new poles were erected for the new cabling.

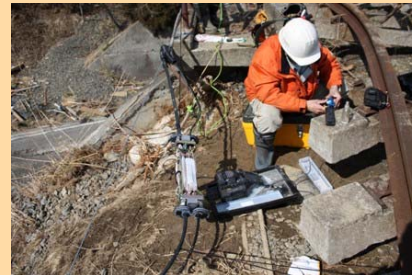
Connection of the core cabling between the existing cable and the backup relay route cable.

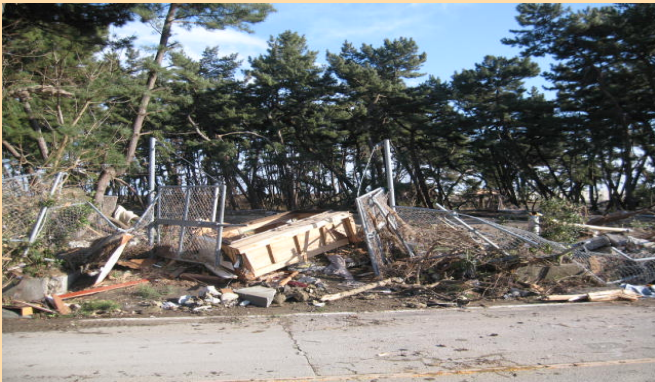
Building was carried 500m away by flood from its original site

- Since the whole Shichigahama Building was lost to floods, a SBM-BOX and IP-BOX (outdoor-use circuit switch) will be installed at the building's original site, to restore services by mid-April.

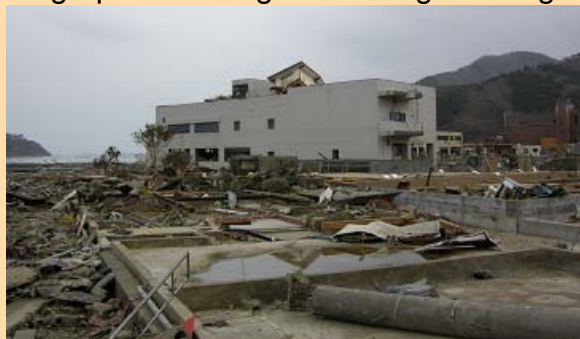
The tsunami greatly damaged the building and flooded the surrounding area

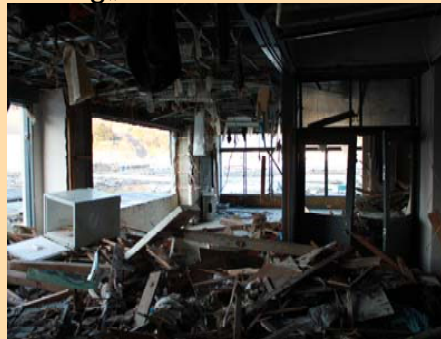
Walls were damaged and the building was filled with driftage

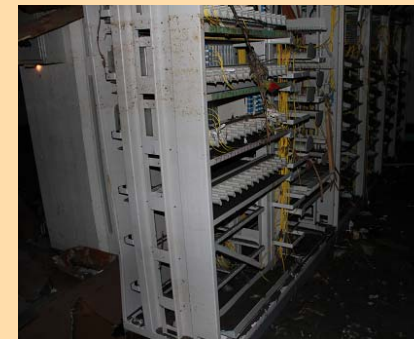
Communication equipment was also damaged by the flooding

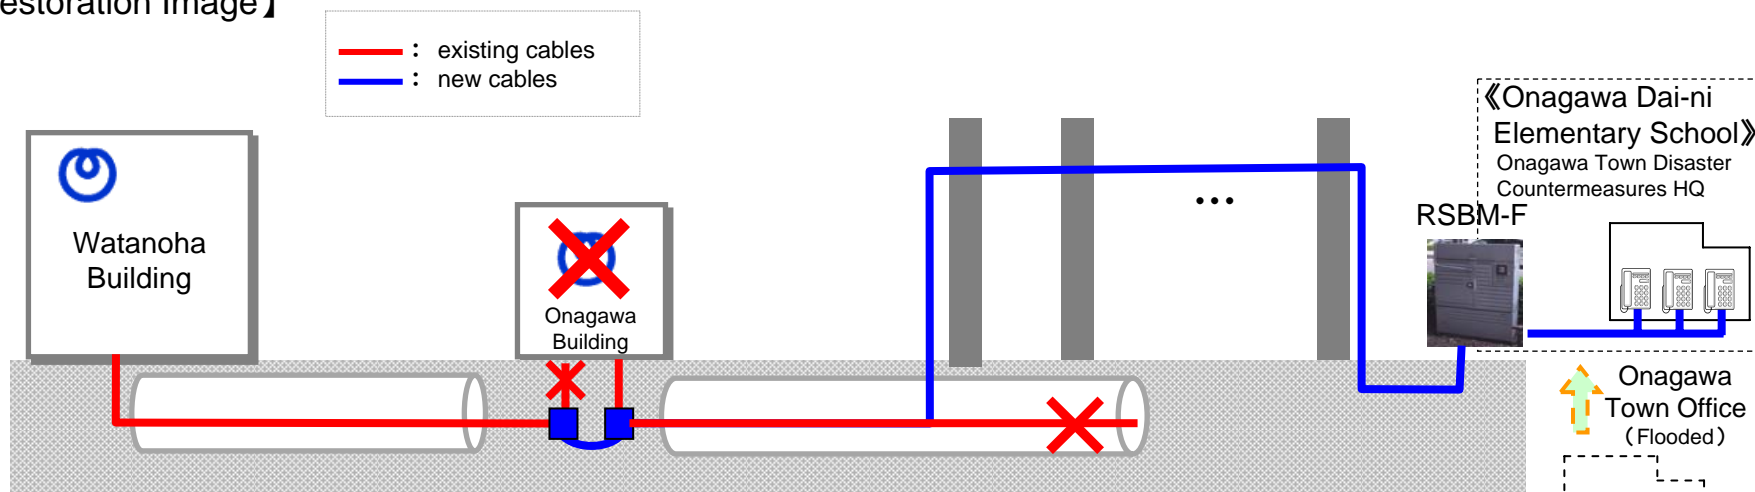
### 【Restoration Image】

\*RSBM : Remote Subscriber Module (Equipment which accommodates PSTN and leased line circuits to be multiplexed and connected to a fiber optic line, connecting to a NTT exchange office building)

- Since the Onagawa Building was flooded and damaged, service is scheduled to be restored by mid-next week through the installation of a RSBM-F (outdoor use circuit switch) in the Onagawa Town Disaster Countermeasures Headquarters, and establishing a connection to the Watanoha Building, which is located at a higher layer within the telecommunication network.

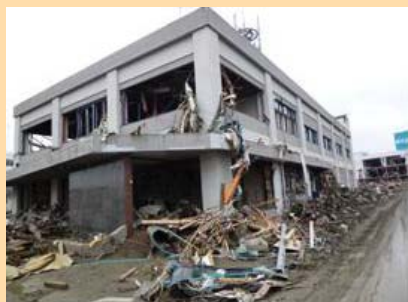
The tsunami greatly damaged the building and flooded the surrounding area

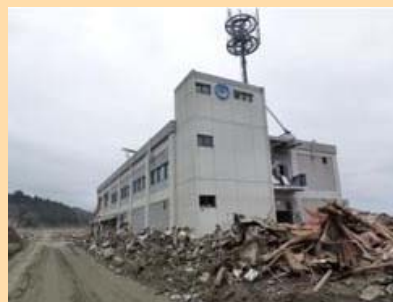
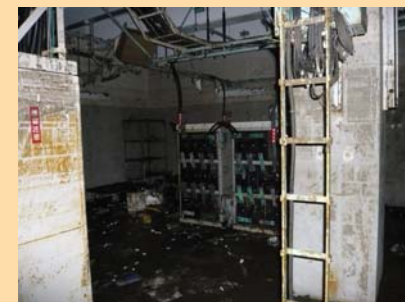
Power equipment was also greatly damaged from the flooding

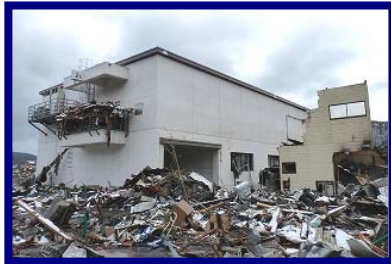
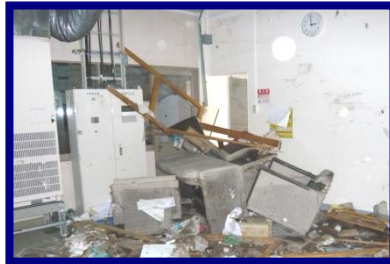
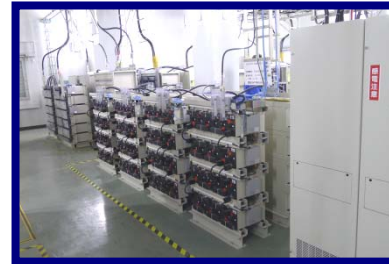
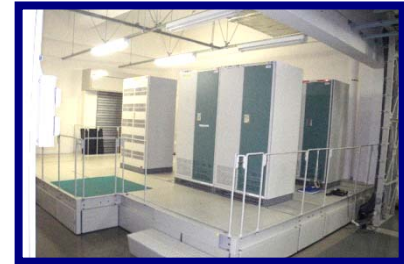
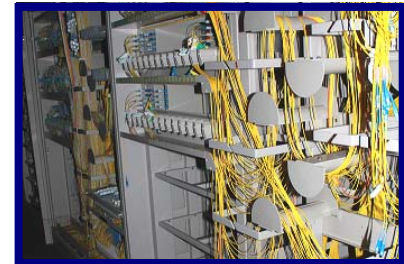
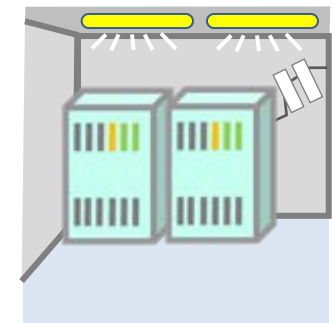
Removal of wreckage  
surrounding the building

Removal of wreckage and  
non-usable equipment  
inside the building

Restoration of building  
power

Installation of  
communication equipment

Restoration  
of services
